PERFORMANCE INNOVATION LABORATORIES

**Failure Analysis of
Vibration Test Cards for Crane
Job ID: TOL0901051**

Report by: Eva Kosiba
Title: Operations Engineering Advisor

Company Name: Crane Division, Naval Surface Warfare Center (NSWC)

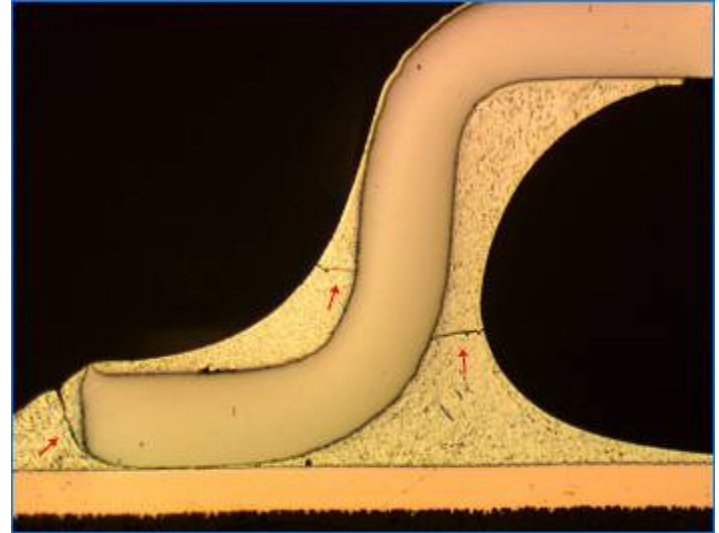
Figure 171: cross section, SN68, U16, left lead solder partial crack, 100x

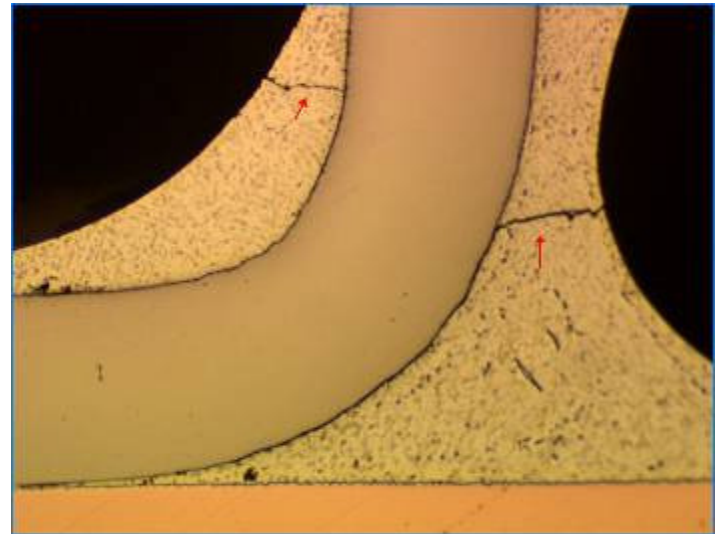
Figure 173: cross section, SN68, U16, left lead solder partial crack, 200xb

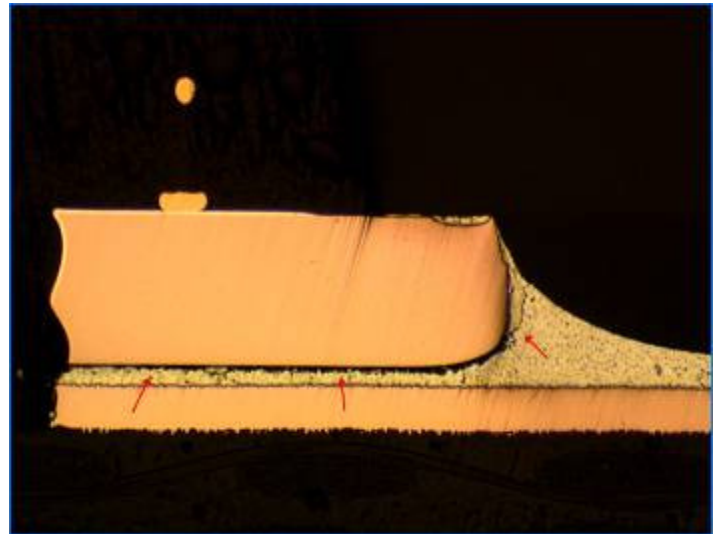
Figure 177: cross section, SN68, U28, right lead solder crack, 100x

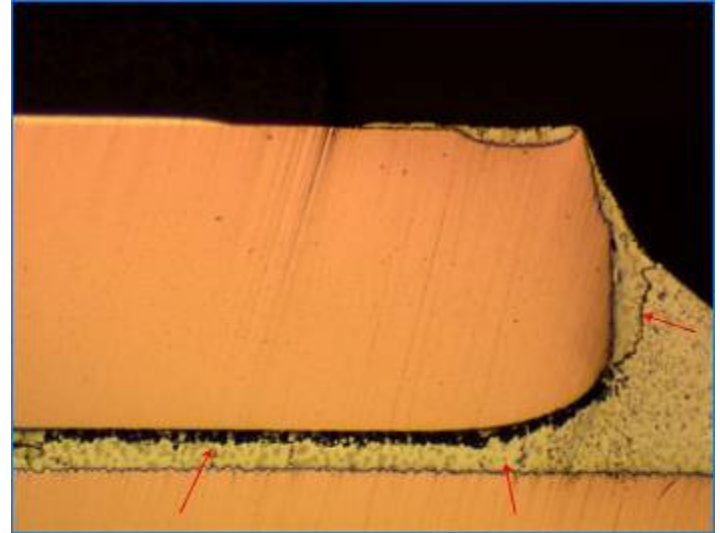
Figure 179: cross section, SN68, U28, right lead solder crack, 200xb

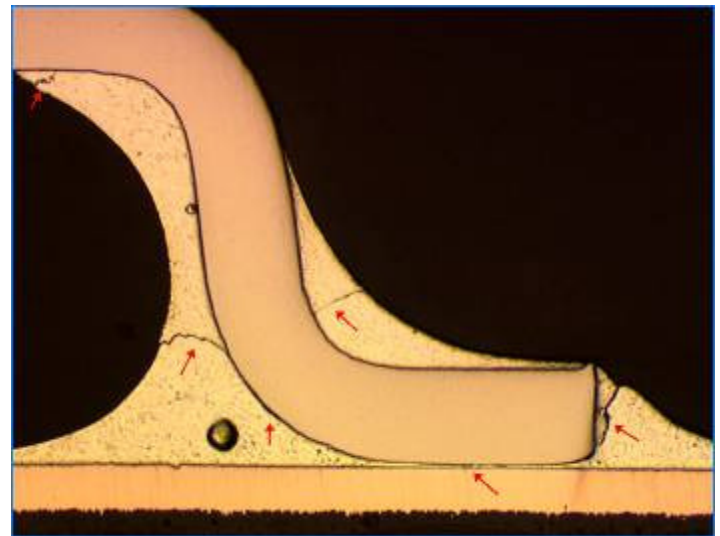
Samples SN68 U29 and SN63 U16 were both re-worked twice with SnPb solder. SN68 U29 is finished with Sn and SN63 U16 is finished with SnBi. The SnBi part experienced extensive solder cracking through-out. The Sn finished part experienced solder cracking at one side of the component.

Figure 181: cross section, SN68, U29, right lead solder crack, 100x

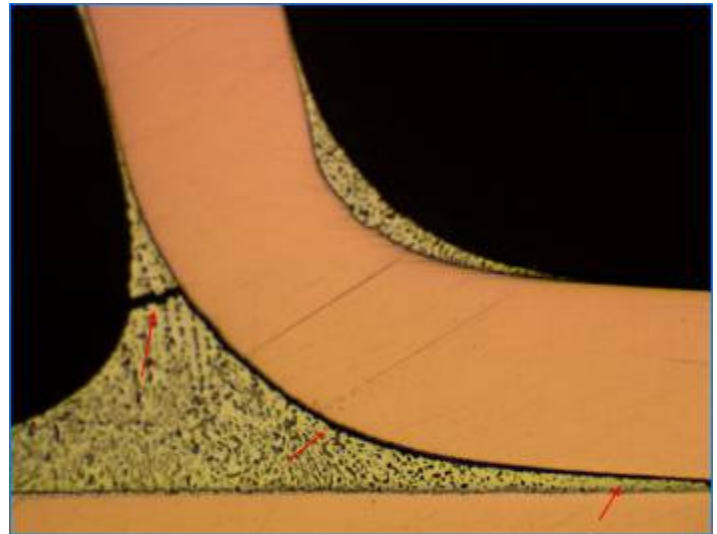
Figure 189: cross section, SN68, U31, right lead solder crack, 200xa

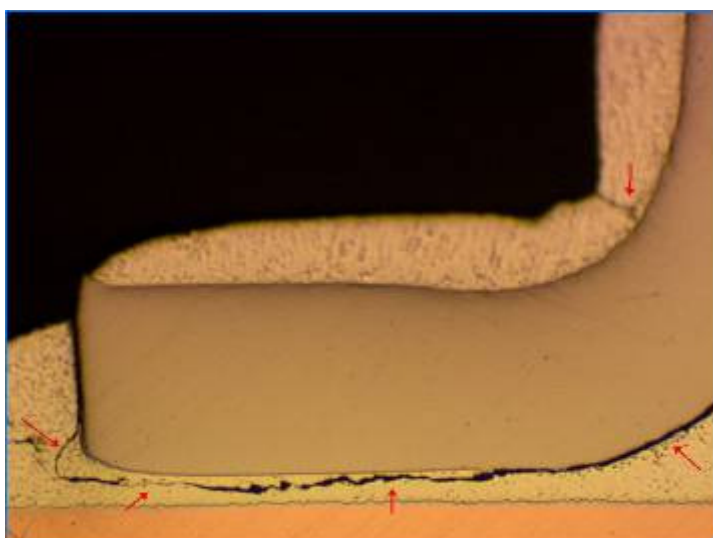
Samples SN79 U12 and SN66 U62 are examples of TSOPs which did not undergo any re-work. They have Sn and SnBi finishes respectively. Both experienced severe solder cracking in leads on both sides of the component.

Figure 192: cross section, SN79, U12, left lead solder crack, 200xa

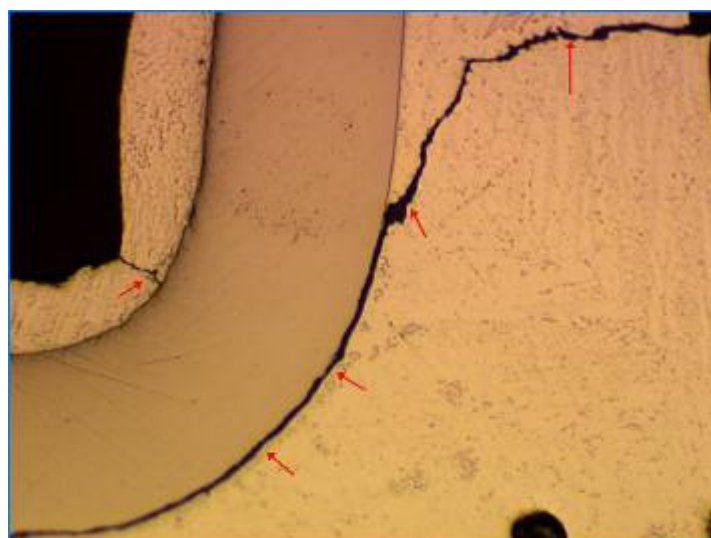
Figure 193: cross section, SN79, U12, left lead solder crack, 200xb

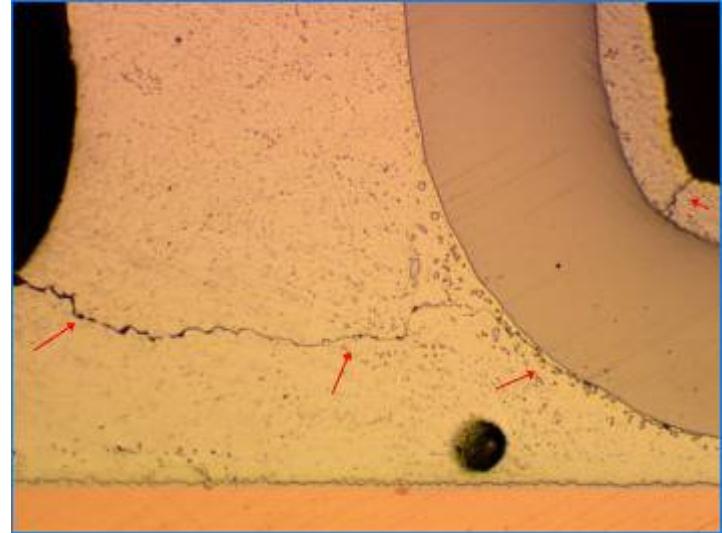
Figure 195: cross section, SN79, U12, right lead solder partial crack, 200xa

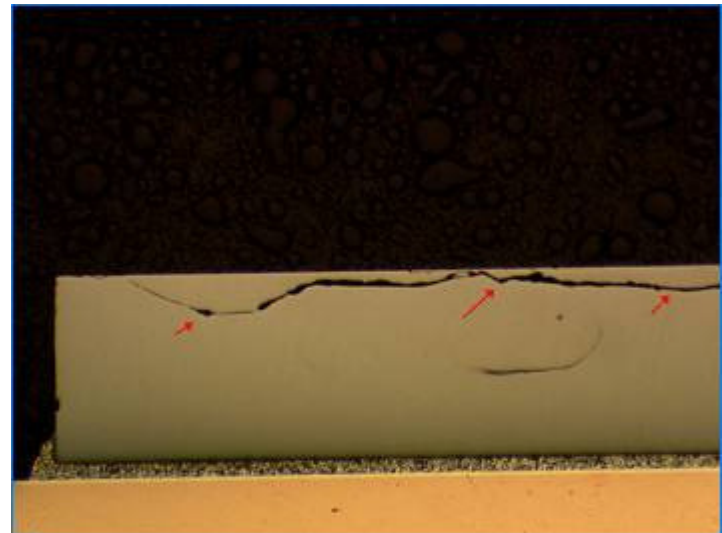
Figure 197: cross section, SN79, U28, comp top crack, 100xa

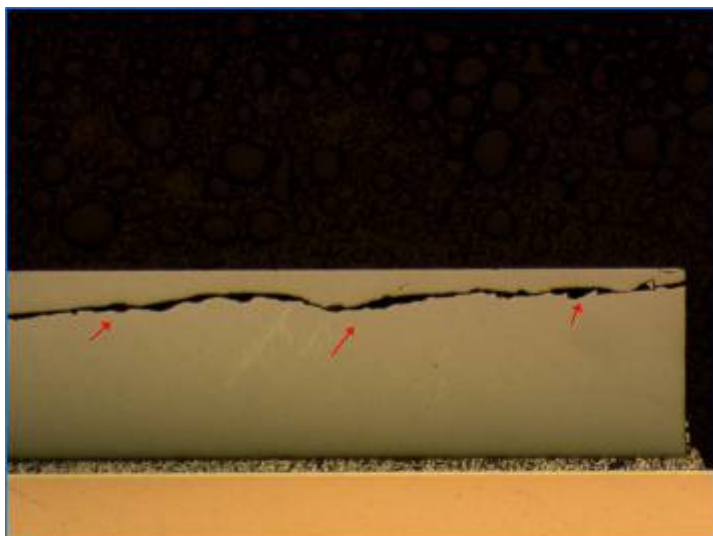
Figure 198: cross section, SN79, U28, comp top crack, 100xb

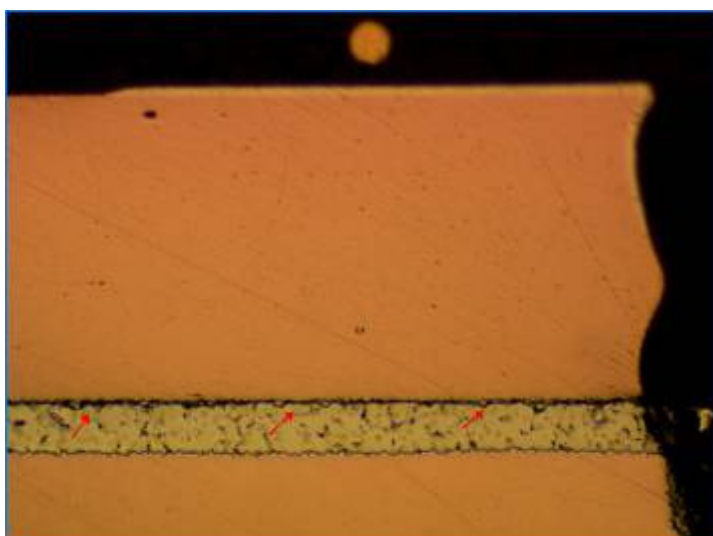
Figure 200: cross section, SN79, U28, left lead solder crack, 200xb

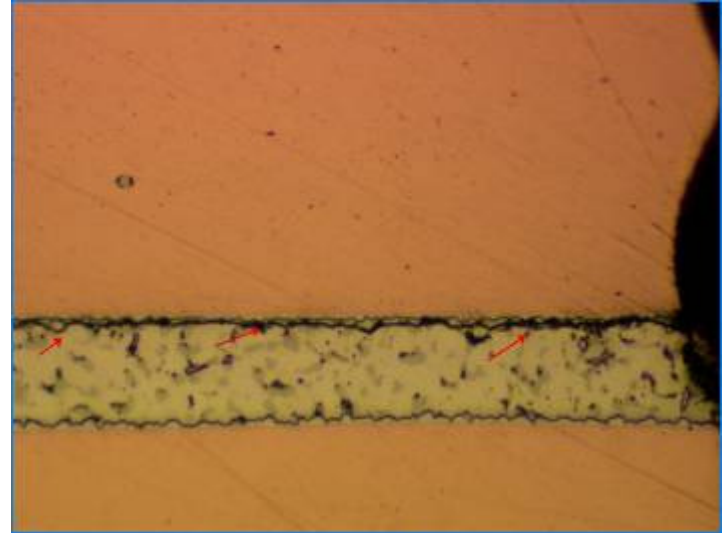
Figure 203: cross section, SN79, U28, left lead solder crack, 400xc
